DCV Safety Alert: 03/2023

## RECOMMENDATIONS FROM THE INVESTIGATION INTO THE FIRE AND LOSS OF THE PASSENGER VESSEL *CONCEPTION*

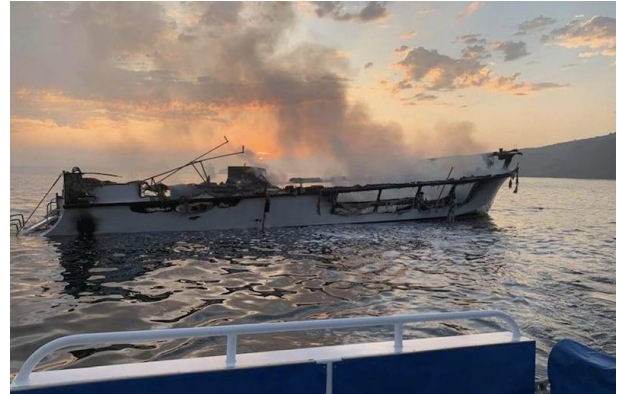
The passenger vessel MV *Conception* at sunrise prior to sinking, September 2, 2019. (Source: Ventura County Fire Department)
